Demonstration of an Environmentally Friendly Paper Artifacts Furnace for Traditional Funeral Service and Data Analysis of Particulate Removal Efficiency of the Furnace

17 – 12 -2013

Background

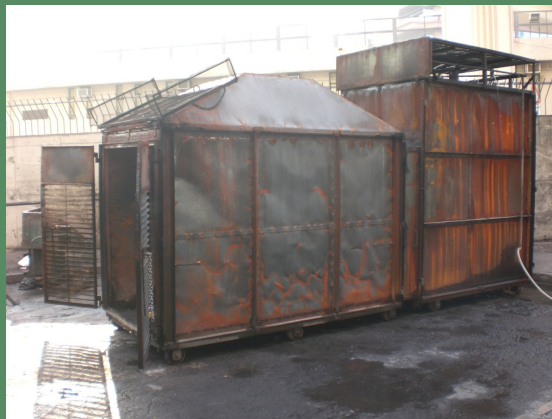
- Traditional Practice
- Emission of particulate and ash leakages
- Back-fires

10 – 15 batches in
1 – 1.5 hours
Each batch about
24 – 25 kg

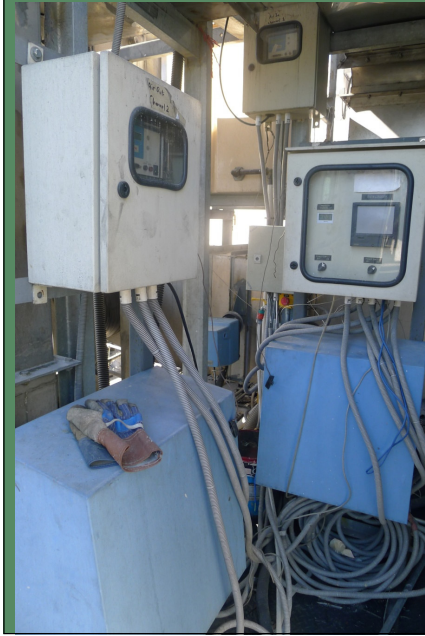
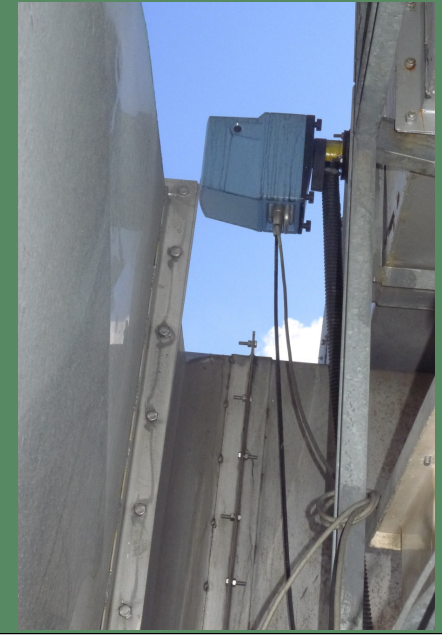
Opacity Meters

Lambert Beer's Rule

$$C_{\text{corr}} \propto -T \cdot \ln(1 - O/100)$$

$$\eta = 1 - C_{\text{corr}} \text{ at furnace} / C_{\text{corr}} \text{ at blower suction}$$

T is flue gas absolute temperature of the flue gas

O is the measured opacity percentage

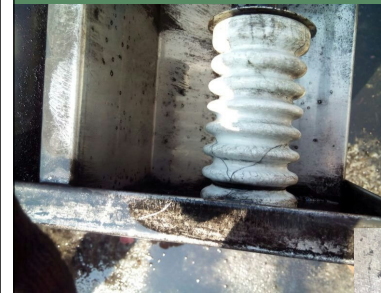
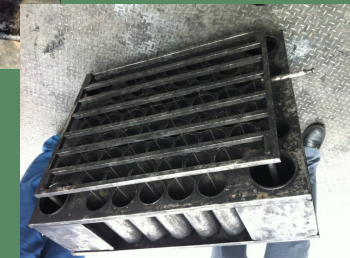
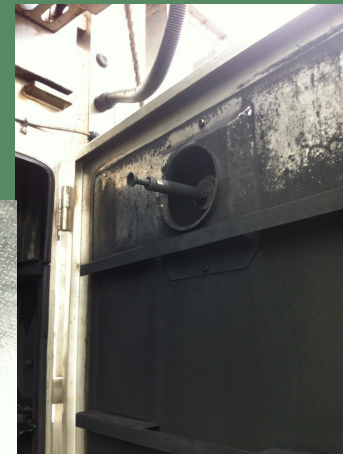
O&M Issues (2)

- EP insulator replacement and electrode connector rods re-arrangement

- Modifications of water scrubber sump overflow pipeworks, valves & spray nozzles, removal of ash deposit and blockages
- Alterations of mist eliminator orientation, scrubber pump inlet connections, rectification of water and gas leakages
- EP insulator replacement and electrode connector rods

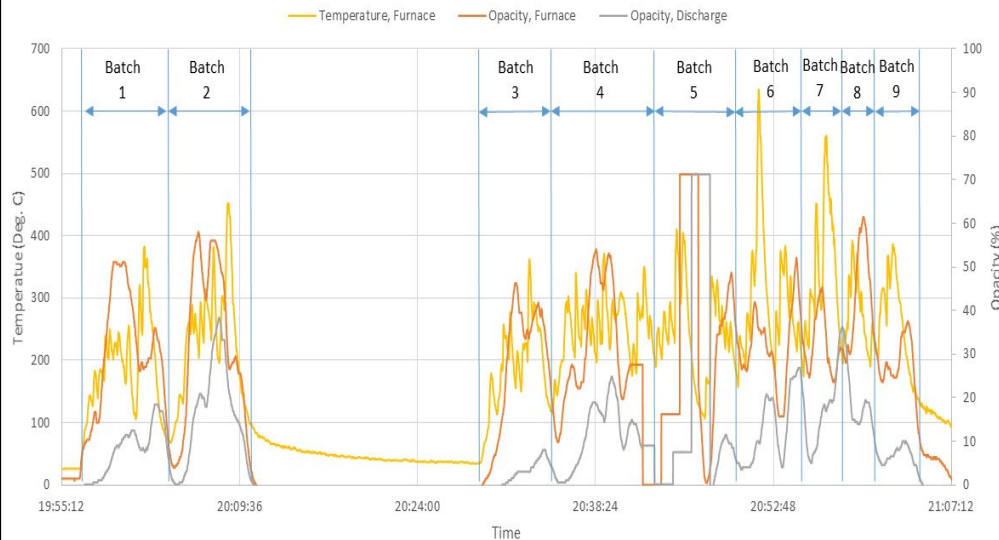
Performance (1)

11 November, 2013 - Temperature & Opacity

- Particulate Removal Efficiency
- High temp. EP bypass, bypass damper leakages, arrangement of EP connector rods in early period contributed to initial low efficiency was later rectified
- Affected by gas temperature

15/7 – 10/11	11 – 16/11
Avg	47.3%	83.5%
Max	95.9%	96.0%

- Discharge opacity ranged from 2.36% - 36.3% averaged at 10.53%
- On average could meet Ringelmann Scale 1 meeting no visual smoke emissions
- Can be improved with better scrubber cooling

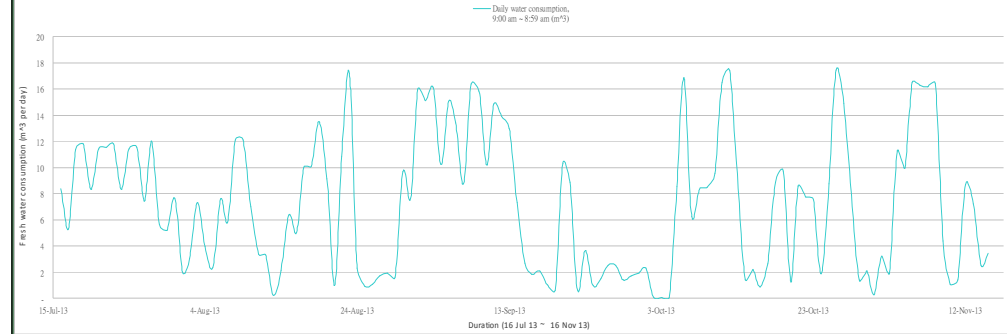
Daily fresh water consumption

- Water consumption high averaged 7.30 m³/day with maximum 17.46 m³/day during tank and sump cleaning once every 2 to 3 days
- Water leakages, control of overflows & blowdowns need to be improved

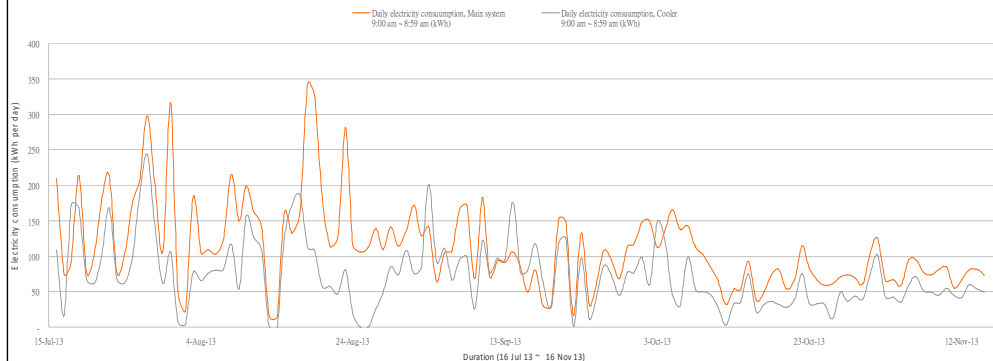
Daily electricity consumption

- Energy consumption high
Main 71.5 kWh/day
Cooler System 49.9 kWh/day (could be reduced)
Overall Plant 121.5 kWh/day

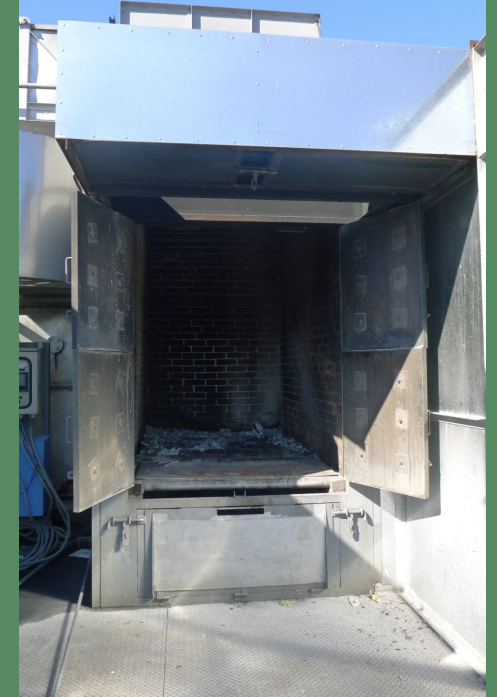
Performance (6)

- 12m³ furnace
- 4-door design
- Sufficient air extraction speed
no back-firing even with all doors open

- With proper design & maintenance, air pollution due to paper artifacts burning can be controlled to acceptable levels
- Based on observation, smoke emissions can be reduced by enhancing scrubber cooling hence lowering gas temperatures & may warrant further researches
- No back-firing with the large furnace & sufficient air extraction
- Prospects exist for reducing water consumption and energy consumption
